# Geoelectrical resistivity survey to determine sliding surface of landslides prone area case study in Ponjong subdistrict Gunung Kidul regency Indonesia

Al Hussein Flowers Rizqi<sup>\*1</sup>, Oky Sugarbo<sup>2</sup>, Mayang Pitaloka<sup>3</sup>  
<sup>1,2,3</sup>Department of Geological Engineering, Institut Teknologi Nasional Yogyakarta

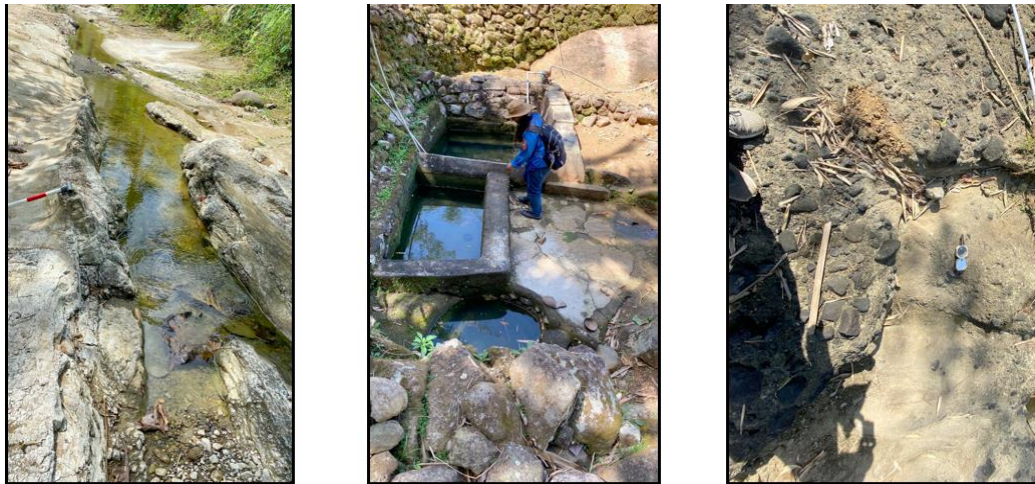
Figure 4. The gauge in Krenceng river, Tambakromo, Ponjong (left). The springs in Grogol village, indicated the structural geology (center). The offset of rock layer (tuffaceous lapillistone and andesitic breccia (right)

Structural geology data was analyzed in stereography analysis with Dips 6 Software. The fault planes, gauge, lineaments, slicken side, and offset of rock layers are structural geology data that supported the fault analysis (Figure 4). The faults data were processed to get the main fault and name of faults based on [17]. There were 5 faults in research area that included in strike slip fault (Table 1).
