Anomalous Investigation of ILS Glide Path Signals on Runway 24 at the Jakarta Air Traffic Service Center

ILS Glide Path;
glide slope accuracy;
signal anomalies;
harmonic distortion;
siting criteria.

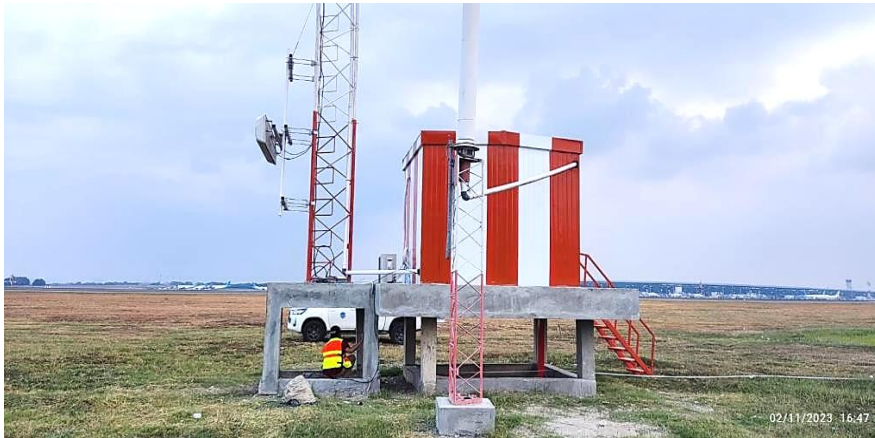
Figure 2. ILS GP Equipment Installation on Runway 24

Meanwhile, the installation layout of the ILS GP equipment on Runway 24 is shown in Figure 2 below.

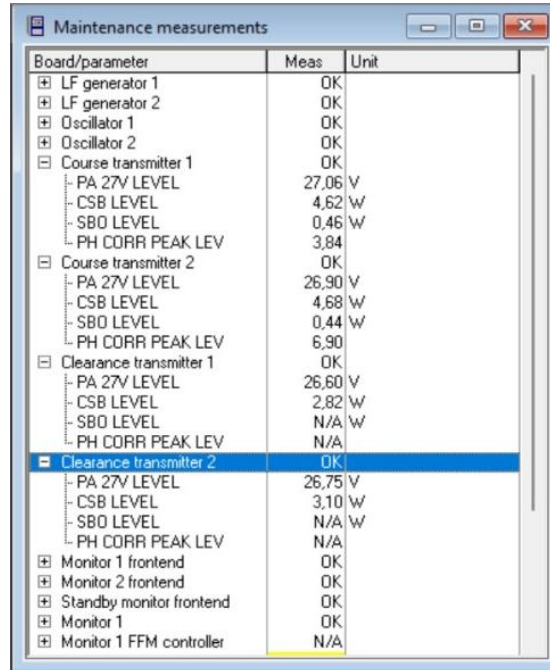
Figure 5. Transmitter Equipment Data

Checking transmitter data is conducted first before performing technical measurements of equipment with measuring instruments that have been prepared. This involved inspecting the transmitter power output of the ILS, specifically at the CSB Course, SBO Course, and CSB Clearance on TX1 and TX2. Figure 5 shows the power output conditions working normally, with TX1 at 4.62 W and TX2 at 4.68 W for the CSB Course, TX1 at 0.46 W and TX2 at 0.44 W for the SBO Course, and TX1 at 2.82 W and TX2 at 3.10 W for the CSB CLR.

Board/parameter	Meas	Unit
LF generator 1	OK	
LF generator 2	OK	
Oscillator 1	OK	
Oscillator 2	OK	
Course transmitter 1	OK	
PA 27V LEVEL	27.06	V
CSB LEVEL	4.62	W
SBO LEVEL	0.46	W
PH CORR PEAK LEV	3.84	
Course transmitter 2	OK	
PA 27V LEVEL	26.90	V
CSB LEVEL	4.68	W
SBO LEVEL	0.44	W
PH CORR PEAK LEV	6.90	
Clearance transmitter 1	OK	
PA 27V LEVEL	26.60	V
CSB LEVEL	2.82	W
SBO LEVEL	N/A	W
PH CORR PEAK LEV	N/A	
Clearance transmitter 2	OK	
PA 27V LEVEL	26.75	V
CSB LEVEL	3.10	W
SBO LEVEL	N/A	W
PH CORR PEAK LEV	N/A	
Monitor 1 frontend	OK	
Monitor 2 frontend	OK	
Standby monitor frontend	OK	
Monitor 1	OK	
Monitor 1 FFM controller	N/A

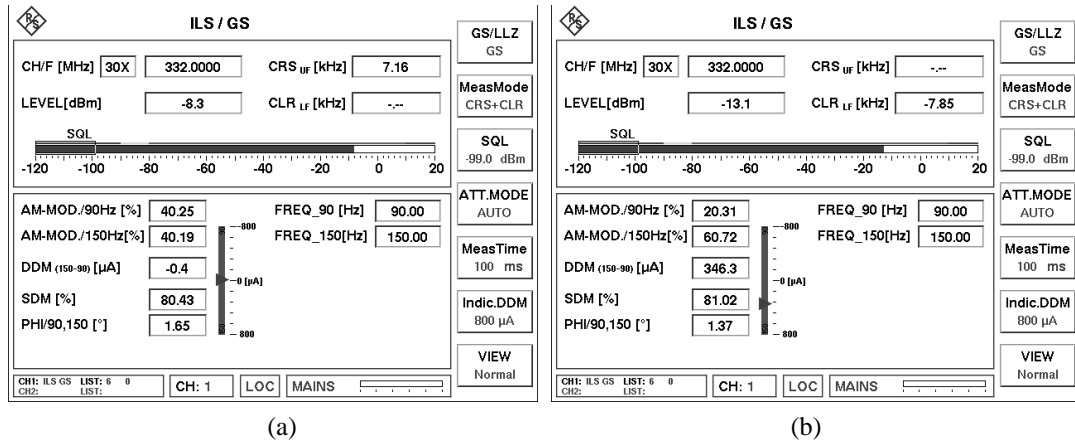
Figure 7. DDM and SDM Measurement Data ILS GP: (a) RF Course, (b) RF Clearance

The next signal parameter measurement was the DDM and SDM parameters on the RF Course and RF Clearance using the Navigation Analyzer. Figure 7 shows that the measured values are also within normal conditions, with the DDM and SDM values on the RF Course being $-0.4 \mu\text{A}$ and 80.43%, respectively, while the DDM and SDM values on the RF Clearance are $346.3 \mu\text{A}$ and 81.02%. The Difference Frequency between the RF Course and RF Clearance is 15.01 kHz.

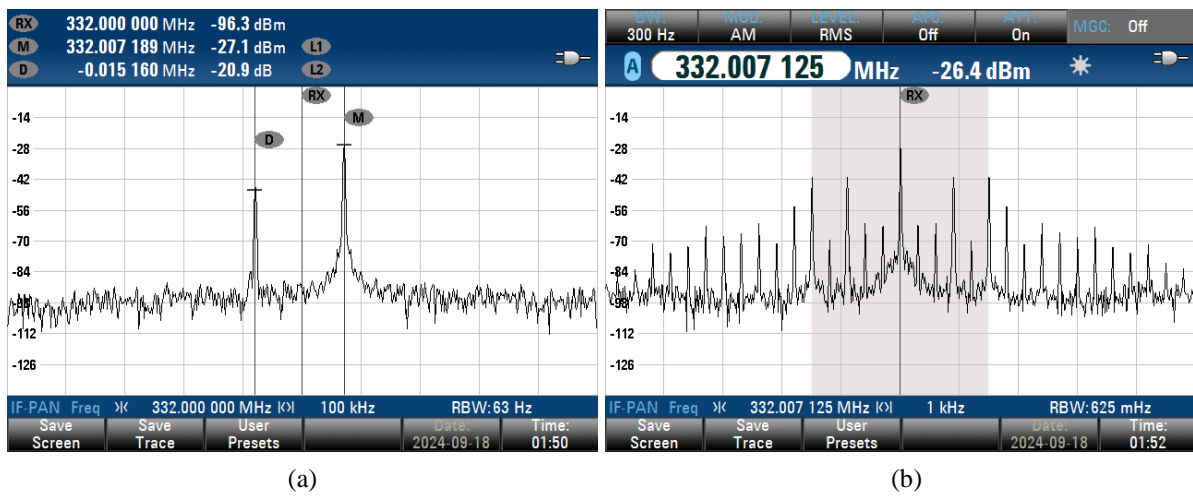
Figure 8. Frequency Spectrum Measurement Data: (a) RF Course and RF Clearance, (b) Audio on RF Course

The frequency spectrum measurement on the ILS GP transmission was also analyzed. Figure 8 shows the spectrum measurement, where the difference frequency between RF Course and RF Clearance was measured as normal at 15.16 kHz. However, during the audio measurement with a 1 kHz span, the frequency measured at RF Course was 332.007125 MHz with an RF level of -26.4 dBm . Distortion was found in the audio frequencies at 30 Hz, 60 Hz, 120 Hz, 180 Hz, 240 Hz, 270 Hz, 300 Hz, and 450 Hz. This could cause interference and potentially affect the quality of the DDM signal parameters being transmitted and received by the aircraft.

To validate the findings, a comparison was made with ILS GP transmissions at Adi Sucipto Airport, Yogyakarta, and Juanda Airport, Surabaya. The comparison of technical aspects, including test parameters and frequency test results, at ILS GP locations with the same brand, namely ILS Adi Sucipto, Yogyakarta, and ILS Juanda, Surabaya, is shown in Figure 9. During the frequency test measurements at ILS GP Yogyakarta and Surabaya, no harmonic audio frequencies were detected. The measurement results at ILS GP Yogyakarta showed a frequency of 331.4 MHz with a received RX level of -31.5 dBm, while at ILS GP Surabaya, the operating frequency was 334.4 MHz with a measured RX level of -43.5 dBm. Spectrum analysis at these locations showed no significant harmonic distortions, reinforcing the hypothesis that the distortions at Runway 24 are abnormal and require further mitigation.

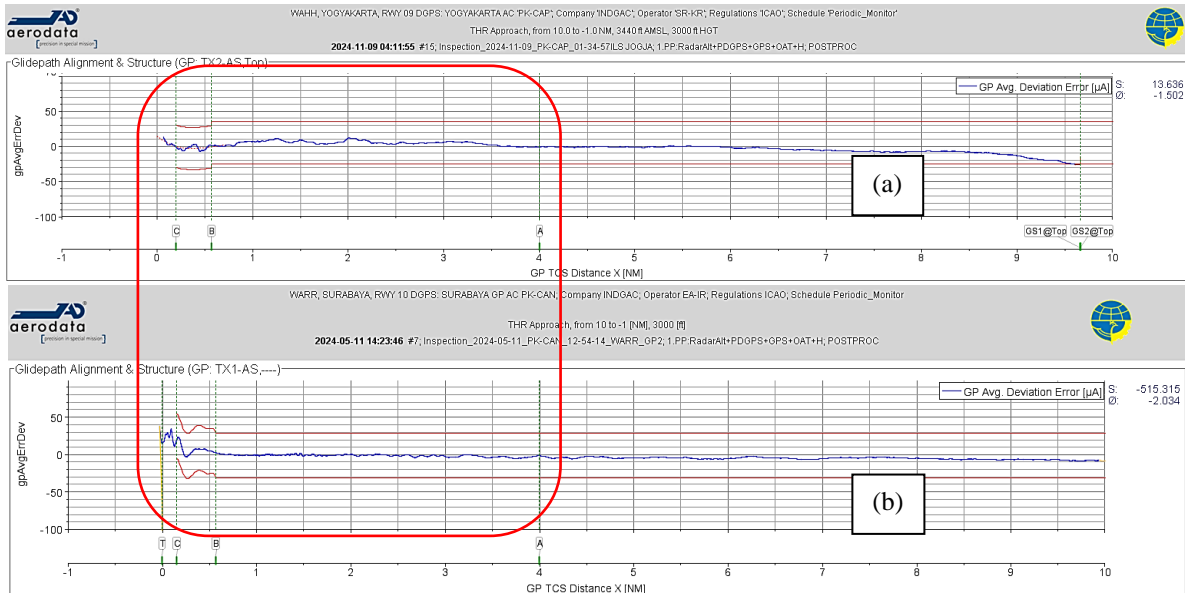
Figure 11. Comparison of ILS GP Parameter Readings, DDM (μA) at Yogyakarta (upper) [25] and Surabaya (lower) [26]

The comparison with other airports confirms the anomaly, suggesting both technical and environmental factors as potential causes. The flight inspection results for ILS GP Yogyakarta and Surabaya are in normal condition with no signal anomalies, as shown in Figure 11.

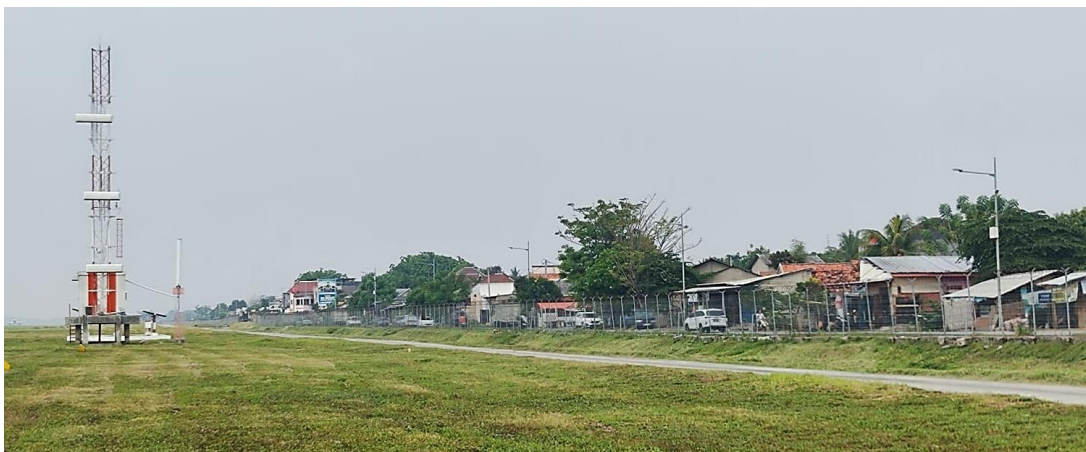
Figure 12. Observation of obstacles such as a metal boundary fence, perimeter road, residential buildings, and a river.

Direct observations and measurements conducted in the critical and sensitive areas, as well as measurements using Google Earth, also indicate environmental discrepancies with the standard siting criteria for ILS GP. In the critical area, there is a river located 19.5 meters from the ILS GP antenna, and in the sensitive area, there is a metal fence located 36.7 meters away with a height of 2.8 meters extending toward the landing angle. Additionally, there is a perimeter road and residential buildings still within this area, which does not comply with the standard siting criteria for ILS GP.

In both Figure 12 and Figure 13, it can be analyzed that there are obstacles in the critical and sensitive areas, as well as uneven terrain in front of the ILS GP antenna, which can significantly affect the graph readings of the flight inspection results. Therefore, it is crucial to create an ideal condition in these areas so that the ILS GP calibration test results for DDM/GP Average Deviation parameters can be satisfactory, and the ILS navigation service can be used for aircraft landing on runway 24.

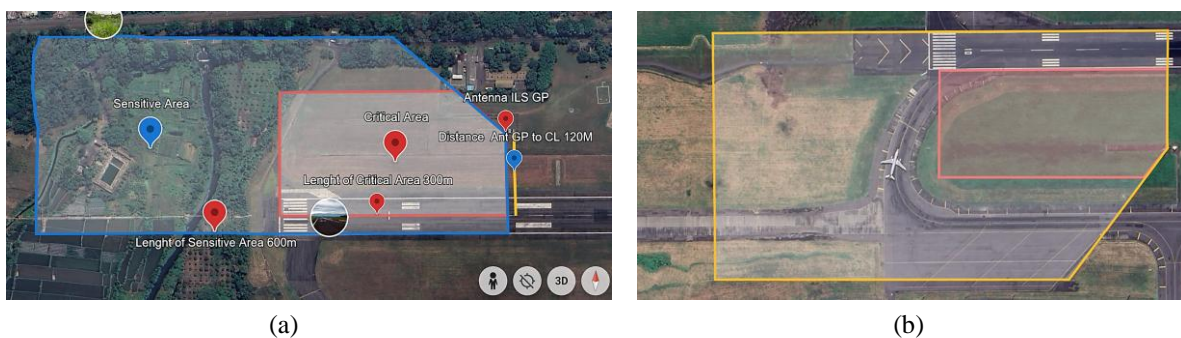
Figure 14. Observation of Siting Criteria for ILS GP: (a) Yogyakarta and (b) Surabaya

Meanwhile, a comparison of the environmental aspects is also observed in the siting criteria for ILS GP at Yogyakarta and ILS GP at Surabaya as in Figure 14.

In the Google Earth observation (Figure 14), it shows that at the airports Yogyakarta (a) and Surabaya (b), there are no significant obstacles, and no buildings, houses, or rivers are visible in the critical or sensitive areas. This reinforces that the flight inspection results at both airports are normal. One of the reasons for this is due to the environmental factors, which are still in accordance with the required standards and criteria.
